TRANSPORTATION SAFETY

REFLEXIONS

Issue 19 – January 2002

M A R I N E

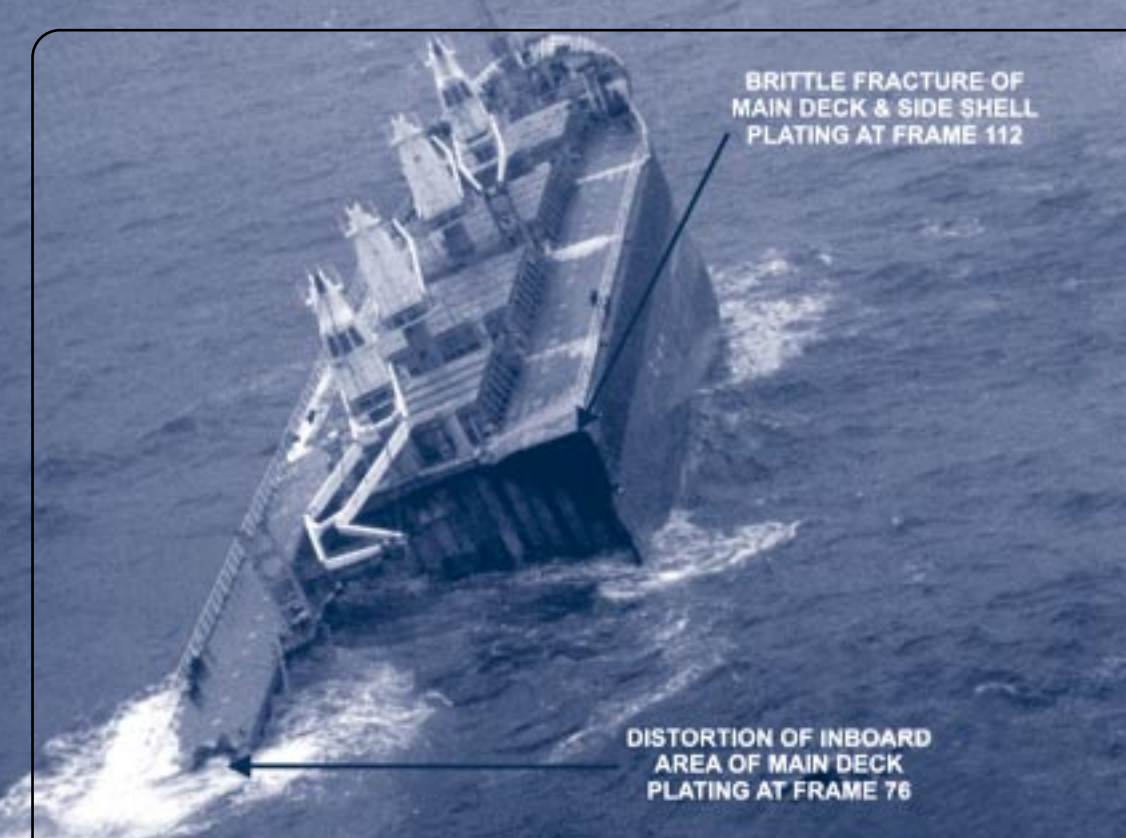
Broke in Two

On 16 January 1998, the bulk carrier *Flare* broke in two approximately 45 miles southwest of the islands of Saint-Pierre-et-Miquelon in severe weather conditions. It was en route from Rotterdam, Netherlands, to Montréal, Quebec. The stern section sank within 30 minutes; the bow section sank four and a half days later off Nova Scotia. An extensive search-and-rescue (SAR) operation was undertaken in very difficult conditions. Twenty-one of the crew perished; four survived. There was widespread, non-recoverable fuel oil pollution from the sunken stern section. — Report No. M98N0001

loss of longitudinal structural integrity was initiated by rapid brittle fractures in the main-deck plating in way of grain-loading ports and existing fatigue fissure damage near midships. Bottom structural failure, resulting from suddenly imposed compressive loading and excessive localized stress concentrations in way of existing fissure damage, caused the hull to break in two. In addition, the Board found that the loss of life was probably exacerbated by the lack of information from the vessel regarding its location; the MAYDAY was short, incomplete, and difficult to understand, and the EPIRB did not provide any information.

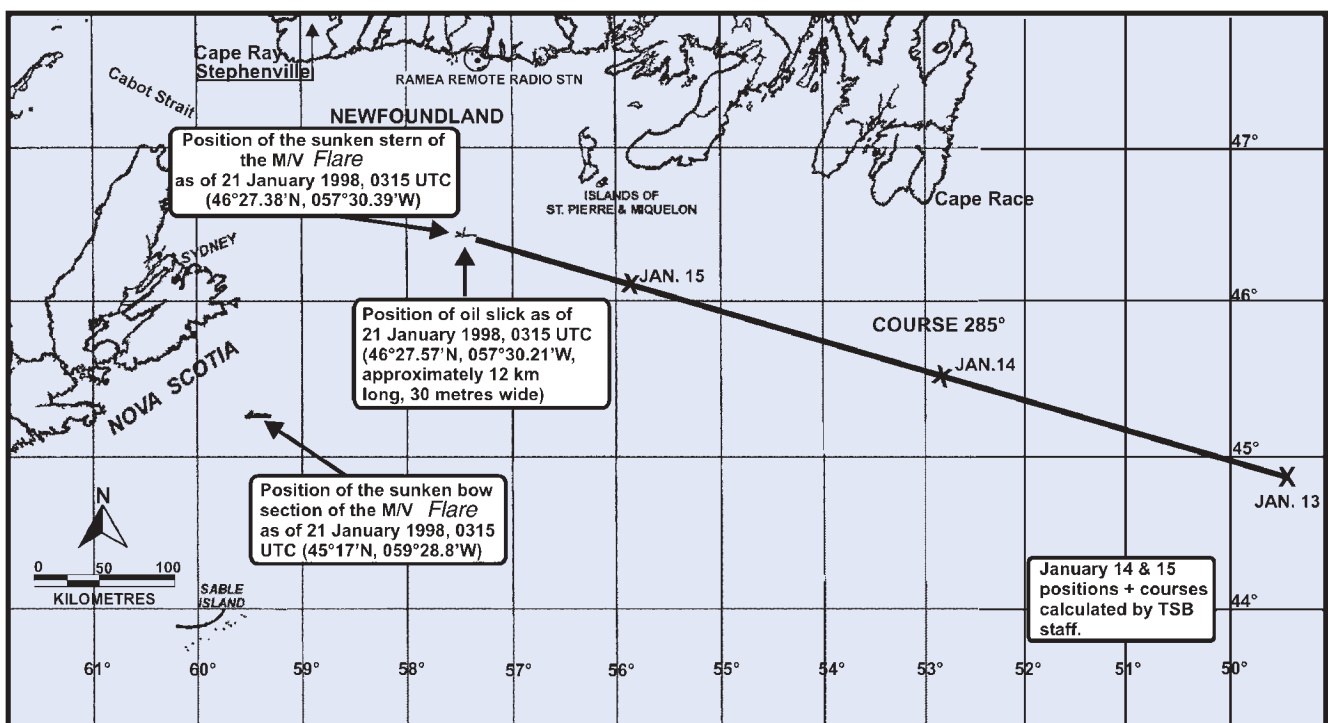
The MAYDAY was short, incomplete, and difficult to understand, and the EPIRB did not provide any information.

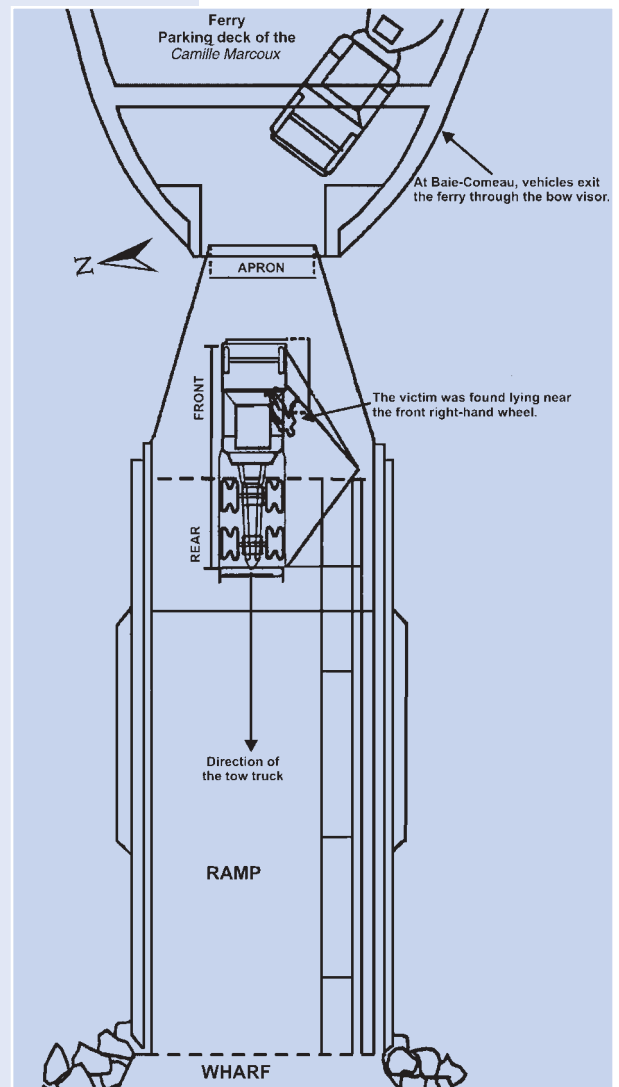
Sketch reproduced from the original drawn by the Sécurité publique, Baie-Comeau.

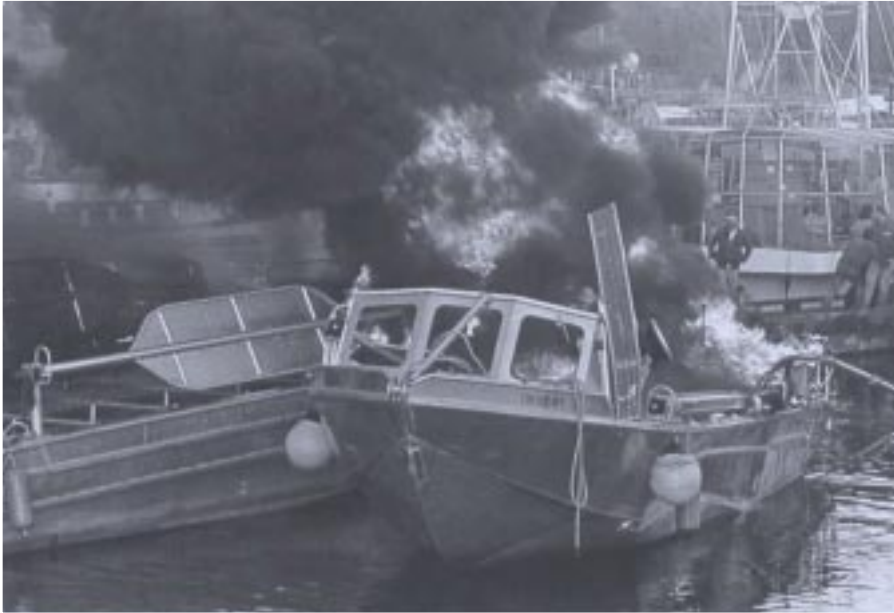
When the operator started the port engine, an explosion occurred, followed by a large gasoline-fuelled fire. The force of the explosion ejected the operator from the *Sha 122*, and he landed on the deck of another vessel. A piece of canvas that wrapped around him before he was ejected saved him from being burned; however, he suffered a shrapnel wound to his knee. The *Sha 122* was extensively damaged and was declared a constructive total loss.
